MTH GP7 Outside Rail Power Pickup Improvement
Mark DiVecchio (SanDiegoMark)
4 Jul 2020

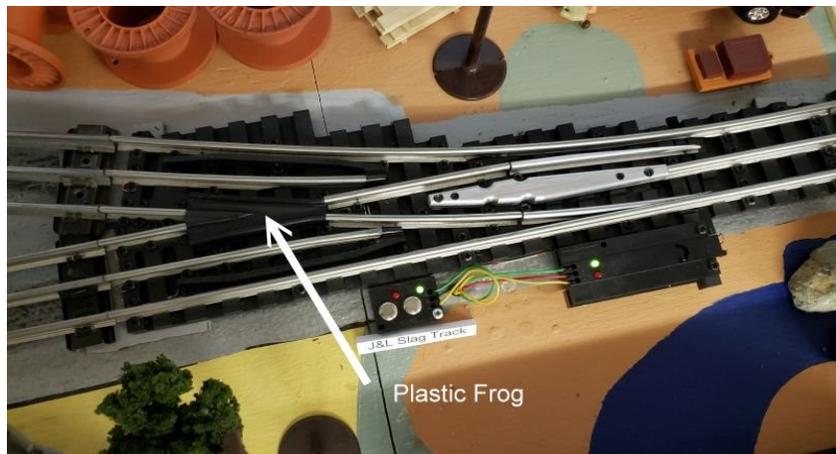
Then, when going over a switch track with a plastic frog (like the RossPlate switches), one of the remaining wheel is on the plastic and thus not in contact with the outer rails.

This leaves ONE wheel to get power to the motor. On my layout, I saw that the one wheel (not on the plastic) raised up slightly and lost contact with the outer rail. The engine lost power and stopped. Sometimes when the engine was going fast enough, it just hiccuped, coasted a bit and then kept on going. But it was a very noticeable jerk.

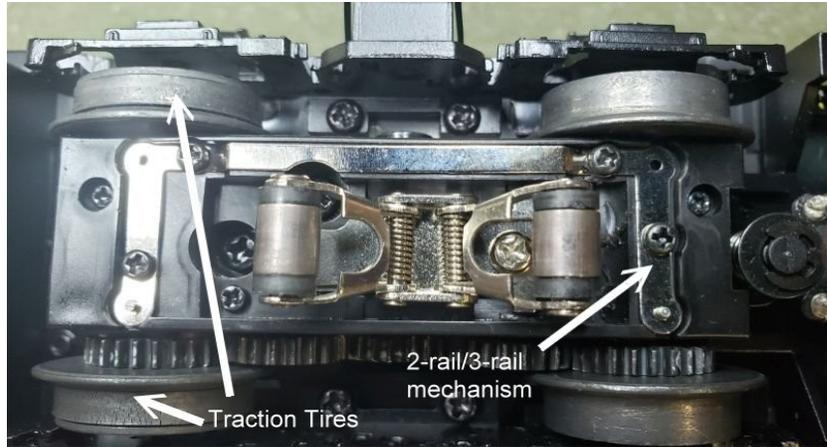
Here is a typical truck on the GP7. There are two traction tires, two full metal wheels and the unusual 2-rail/3-rail powering buss bar. These engines have a switch that lets you run them as either 2-rail or 3-rail engines. I have the switch in the 3-rail position.

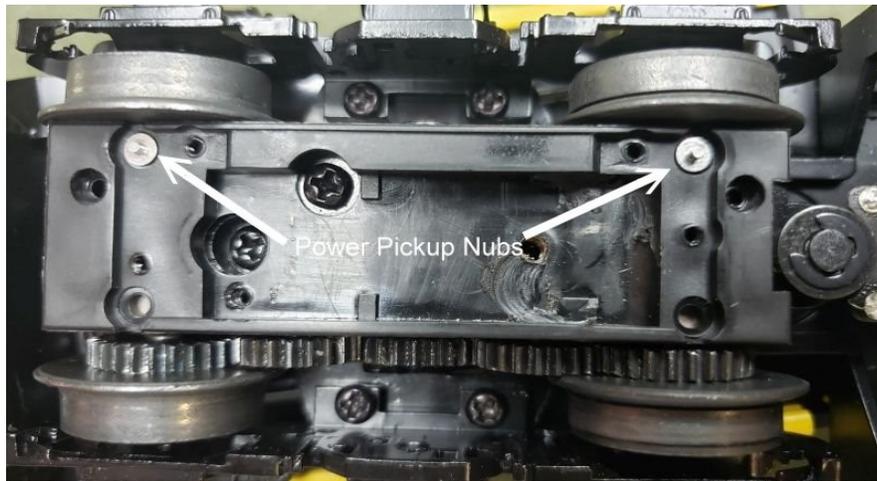
I removed the center rail rollers and the 4 screws holding the buss bar. Here is a photo what I saw.

Underneath the metal bus bar are two power pickup nubs. On this truck, they are in the bottom position (Sorry that the photo does not show this exactly – the nubs can be moved and I was already playing around with that.) The nubs just sit in a hole in the plastic. You can grab them with needle nose pliers and just lift them out.

The nubs transfer outer rail power from the wheels/axles to the buss bar.

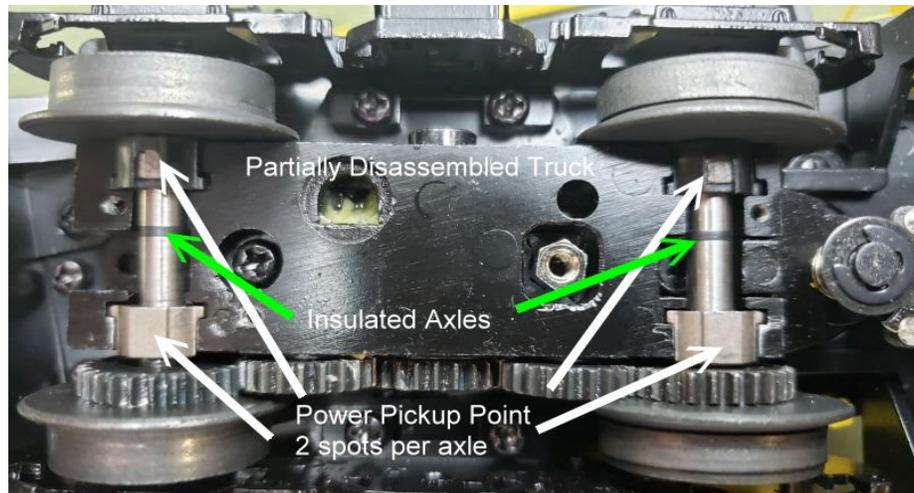
I removed three more screws and then lifted off the plastic part of the truck. In this photo I've exposed the insulated axles and I show the four points where outer rail power can be picked off by the nubs.

Having a power pickup nub on either point of the

traction tire axle is useless. Since the traction tire insulates the wheel from the track, there is never any power at that pickup point.

But you can see in the earlier photo that there is a power pickup nub contacting the power pickup point of the traction tire axle. This may be true on every diesel engine type so this fix may apply to other engines as well.
