SERVICE MANUAL

NO. 3472 - MILK CAR (1949 MODEL)

MILK CAR NO. 3472 (1949 MODEL)

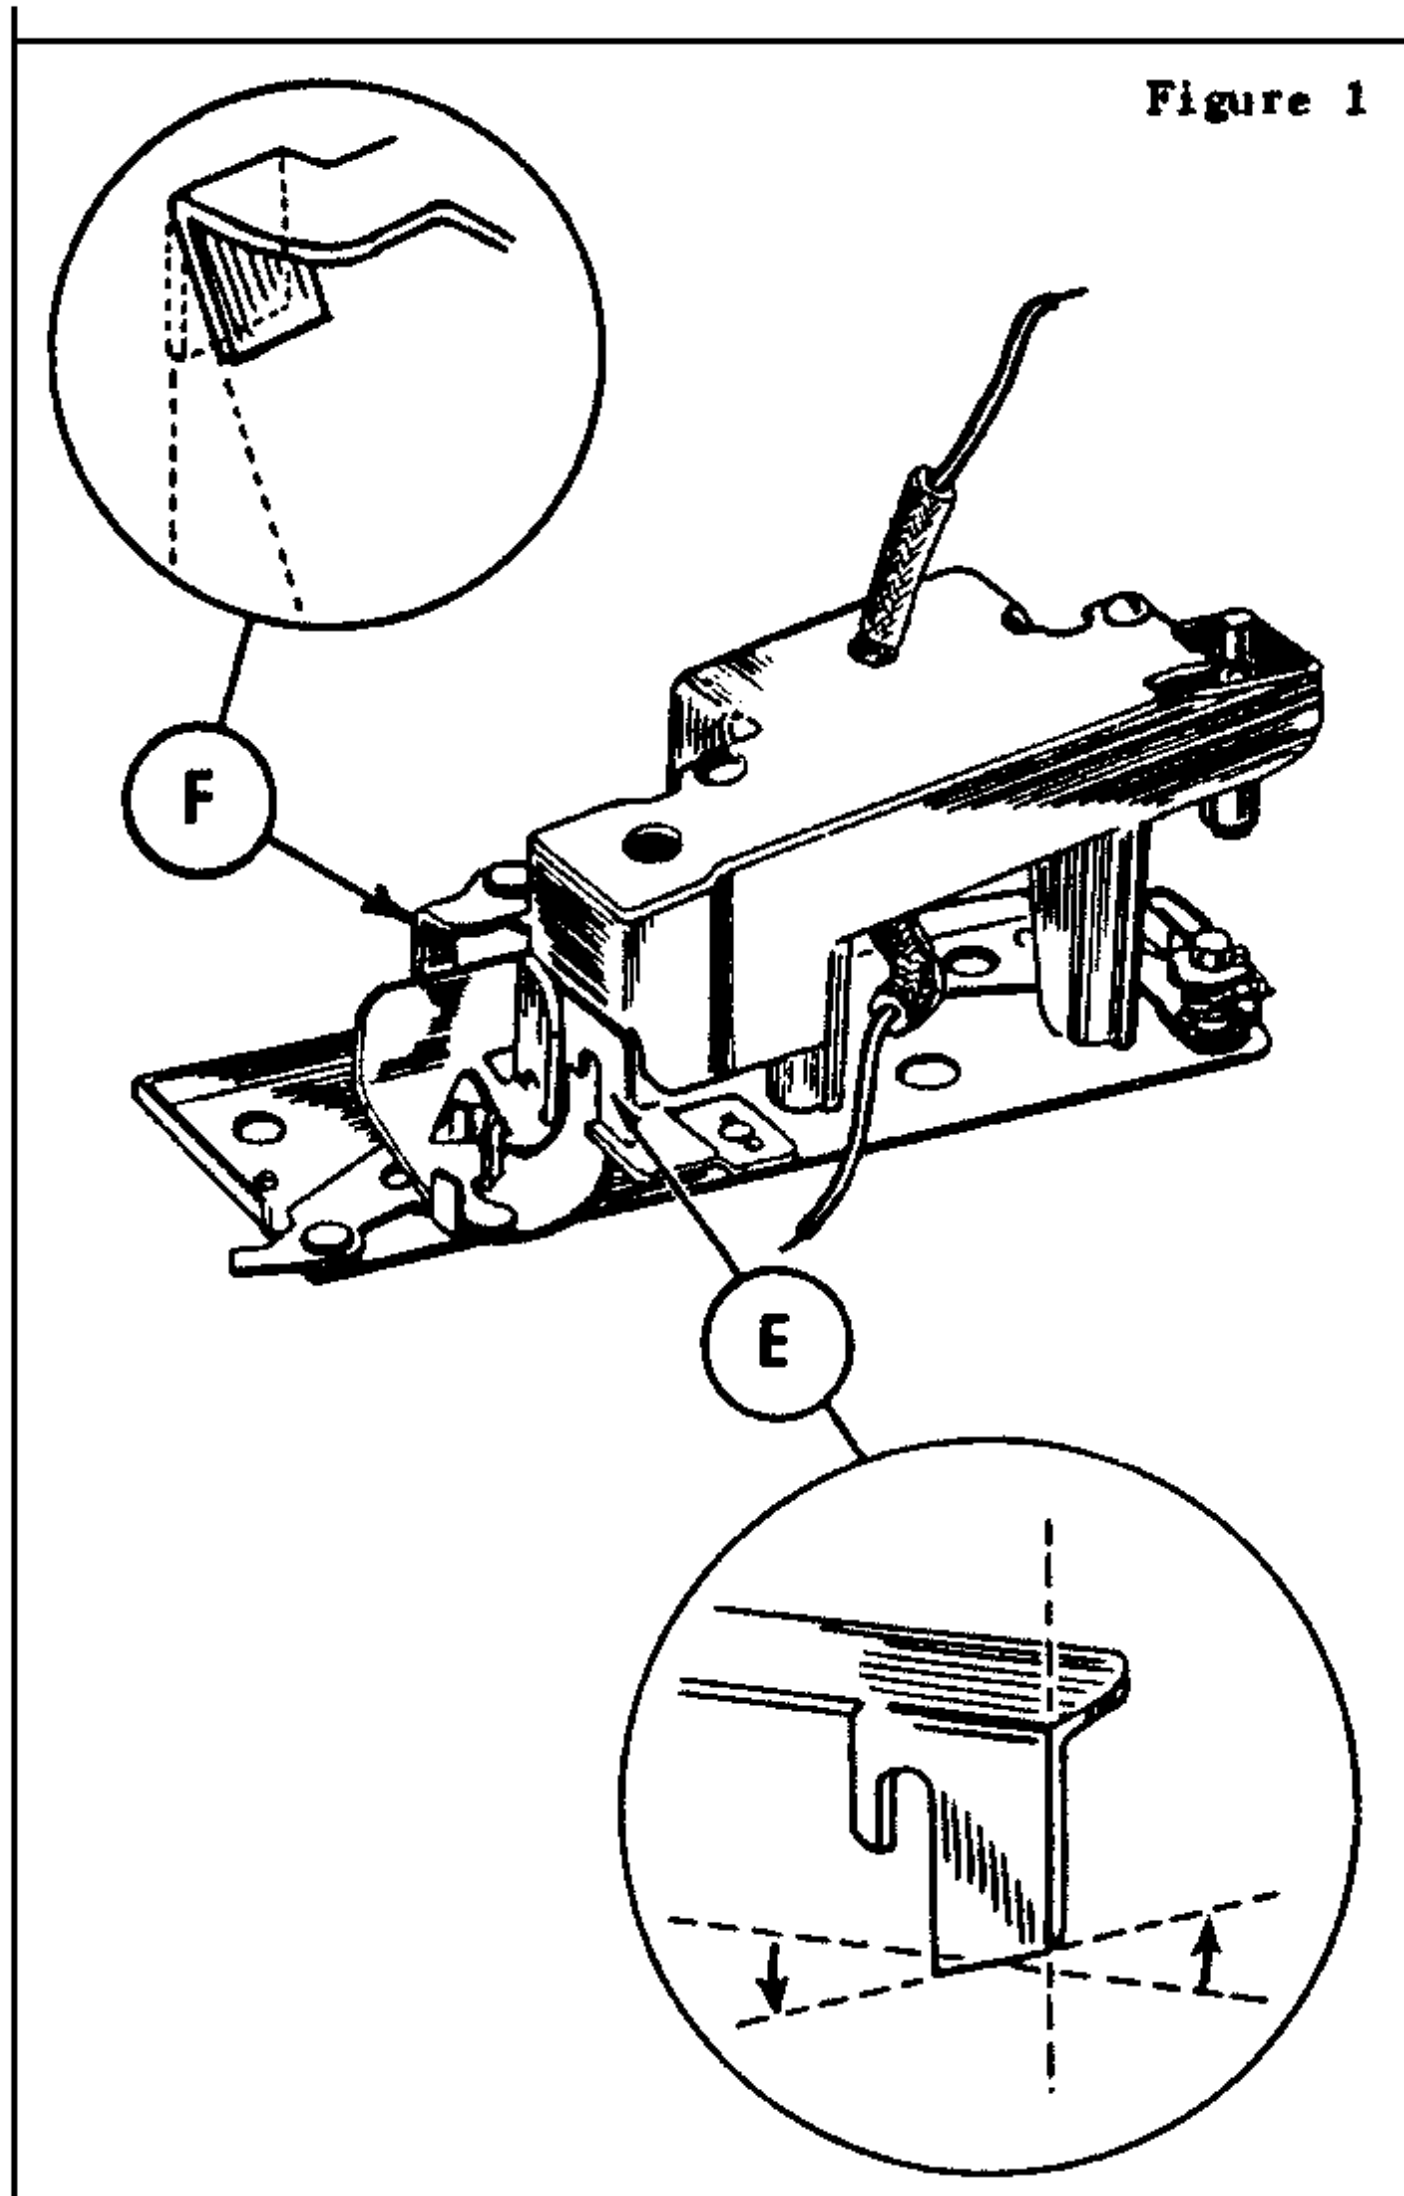
Figure 1

1. Milk cans fail to reach proper location in front of the milk man and therefore are not ejected properly.

This is caused by improper relation between the figure and that part of the can sweep arm which pushes the can in front of the milk man ("E" in Figure 1). Several adjustments are possible to remedy this misalignment. Can sweep arm may be bent outward slightly as shown in exaggerated fashion in Figure 1. The bent tab in the back of the can sweep arm can be adjusted toward the front of the car so that the returning sweep arm strikes it a firmer blow. (See "F" in Figure 1) The left arm and side of the figure can be trimmed slightly with a razor blade, as has sometimes been done in production.

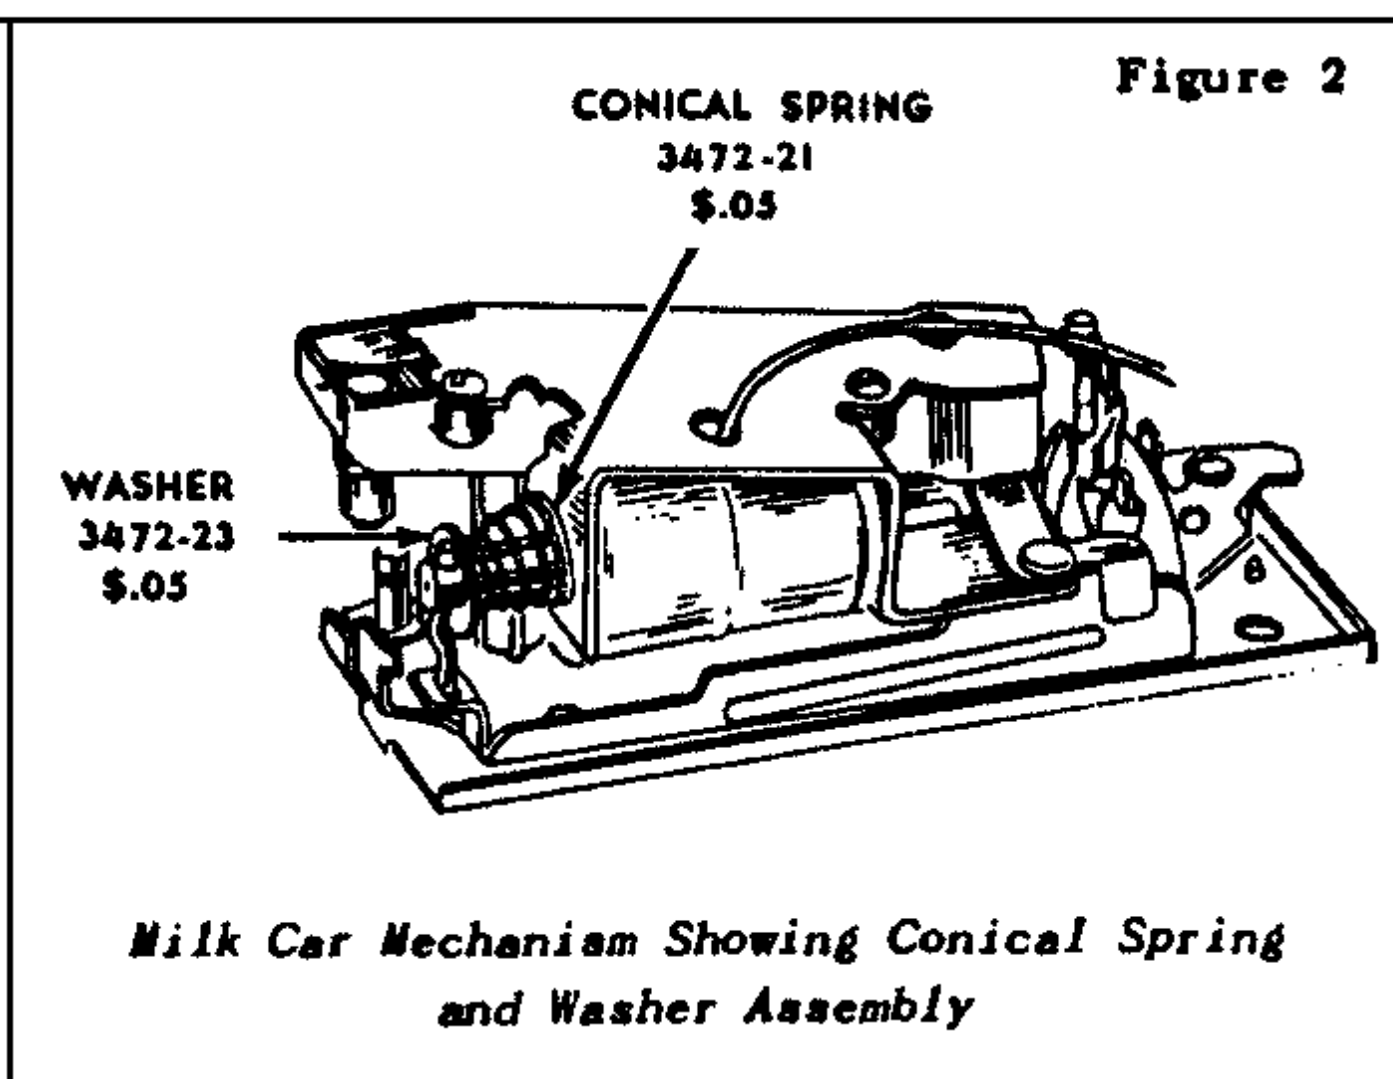
Figure 2

Milk Car Mechanism Showing Conical Spring and Washer Assembly

2. Better unloading can frequently be secured by stretching the return spring (3472-21) to improve the return action of the mechanism. This conical spring together with 3472-23 washer can also be used to replace the 3462-84 return spring used in the mechanism of the No. 3462 Milk Car.
