Keeping them at work

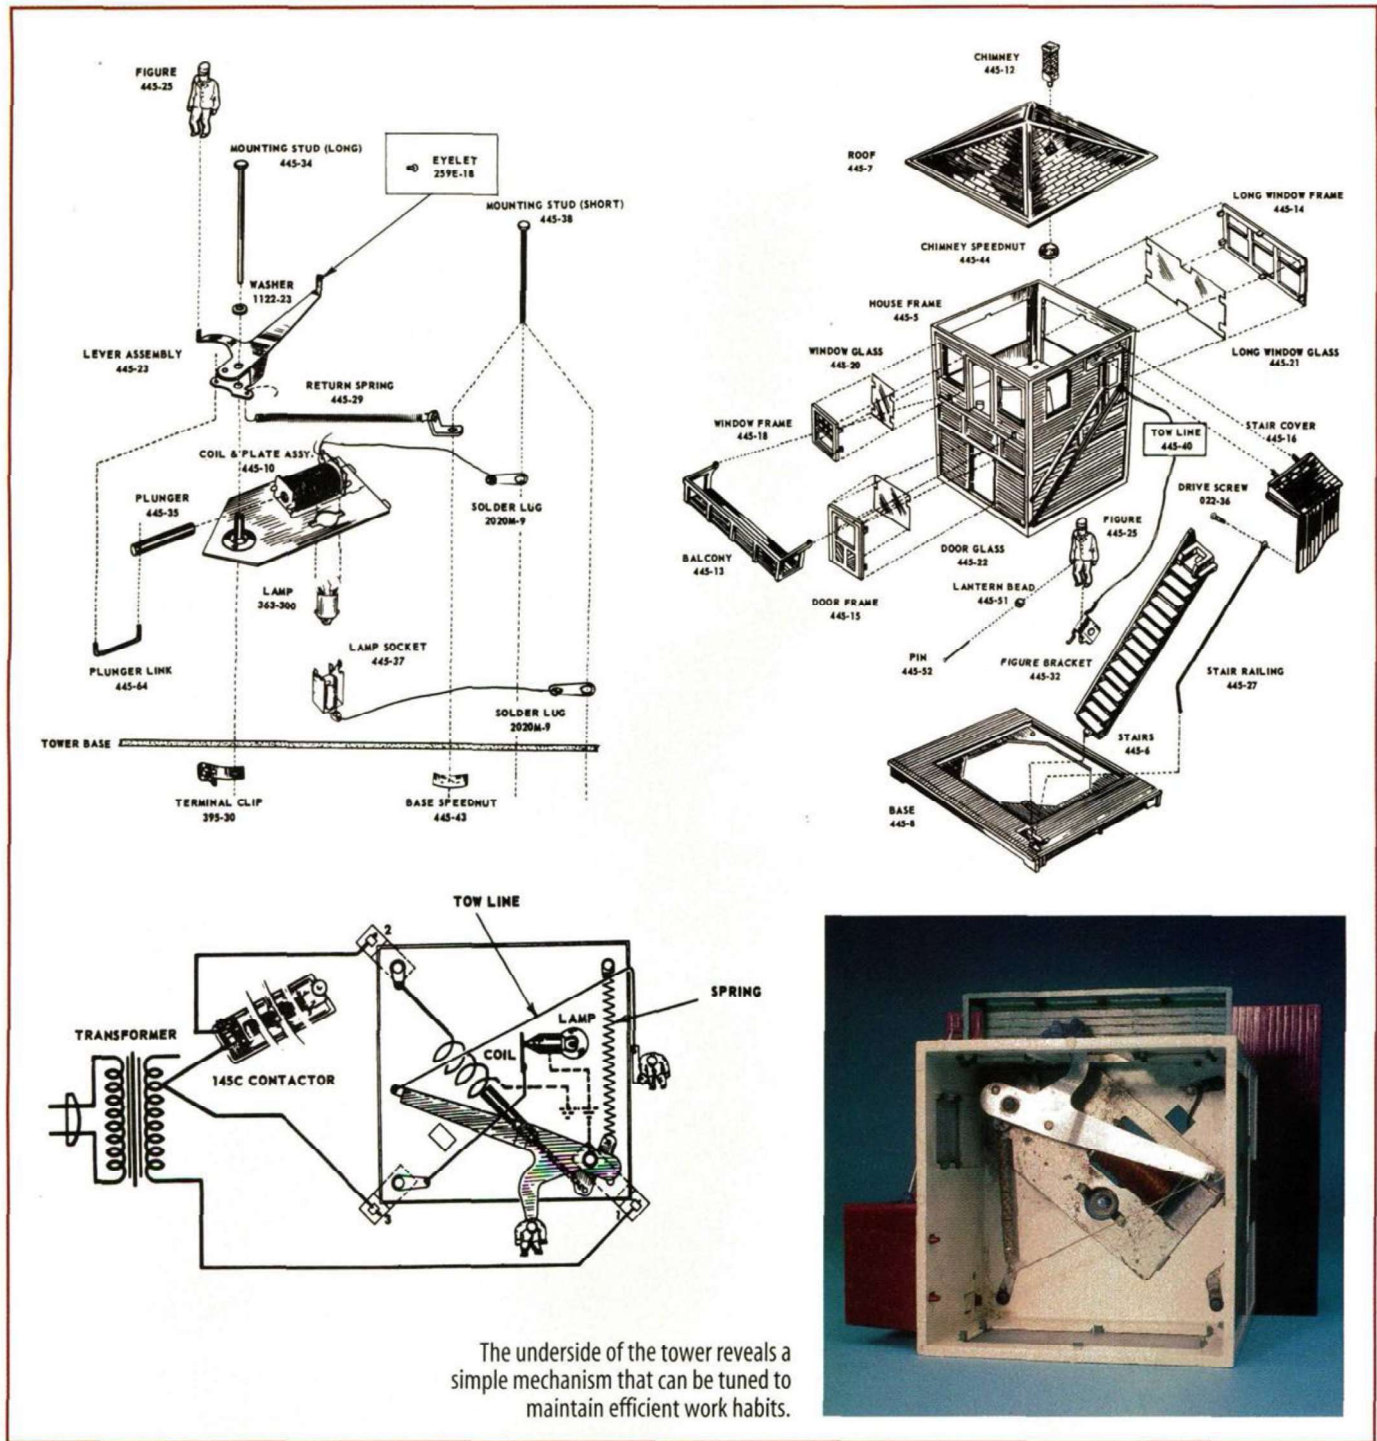
The underside of the tower reveals a simple mechanism that can be tuned to maintain efficient work habits.

This ground is connected to terminal clip no. 1 under the base.

The other lamp wire goes to terminal clip no. 3. The coil is wired to terminal clip no. 2.

If the mechanism is totally dead, the likely culprit is a broken wire or a burned out solenoid coil. Simply repair or replace the defunct wiring.

If the mechanism is simply sluggish, the solenoid plunger may be dirty, or the coil may be distorted from repeated overheating. Clean the plunger with a few squirts of TV tuner cleaner. Replace the distorted coil. A drop of oil on the lever pivot can't hurt.

If the mechanism is erratic or sticky, check to see that the tow line isn't wrapped around the arm or impeded in some other way. After long use, these tow lines have been known to cut grooves in the plastic walls where they enter the building. A small eyelet, such

as Lionel part no. 259E-18, can be inserted into the distorted hole to serve as a bushing and prevent further wear. Also check to see that the metal track upon which lantern man rides is free of old grease and dirt.

If the two men remain outside after the power is turned off, check for a broken or distorted return spring.
