# SERVICE MANUAL

OTTP 95

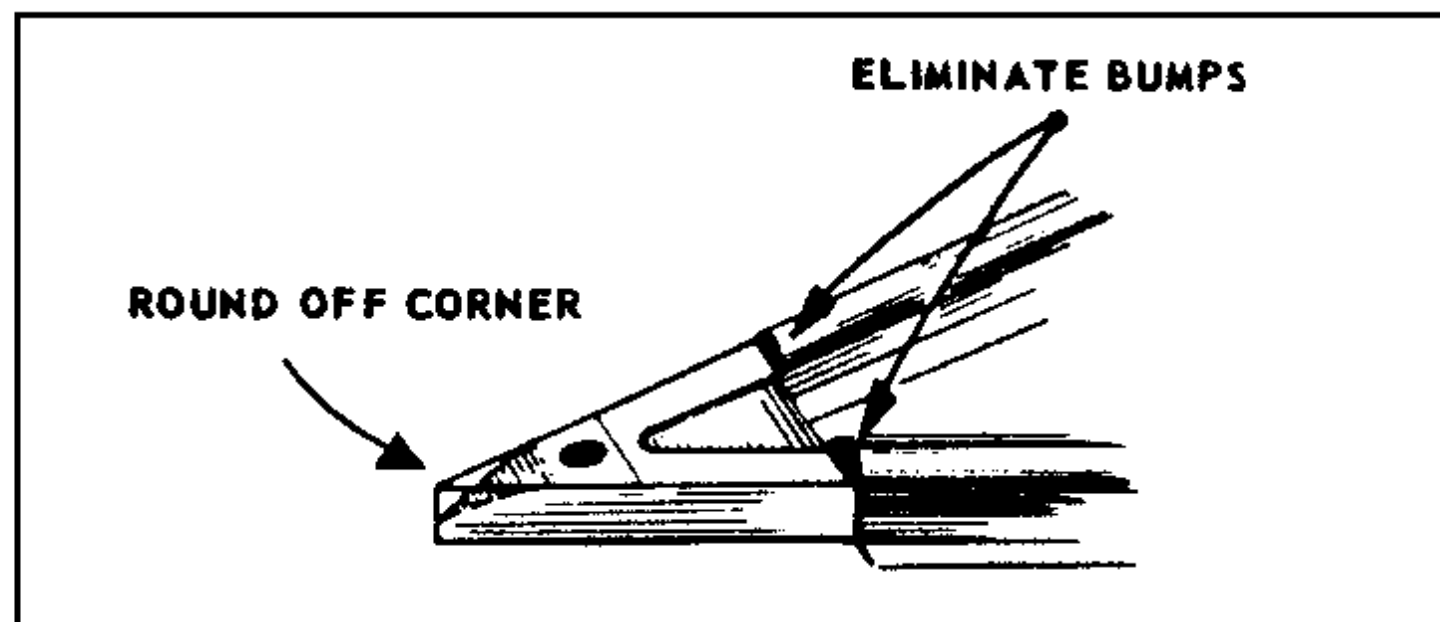
**Reason b:** Locomotive wheels bounce off the Frog Point.

**Correction:** Replace with right and left Frog Points 1122-137 and 1122-138. It is recommended that this replacement be made on all switches serviced.

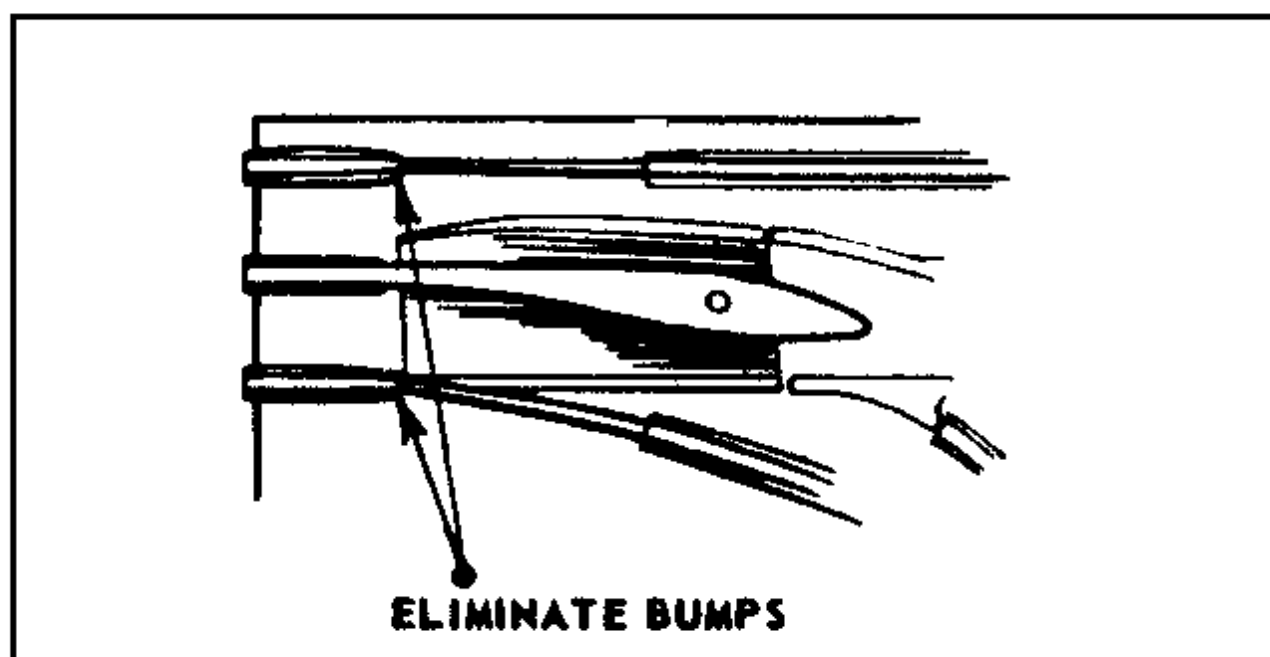
**Reason c:** Locomotive pilot wheels hit rail ends either coming off the Frog Point, or coming off the swivel rail.

**Correction:** Using a light hammer or a pair of pliers eliminate rail projections making all joints between rail sections as smooth as possible.

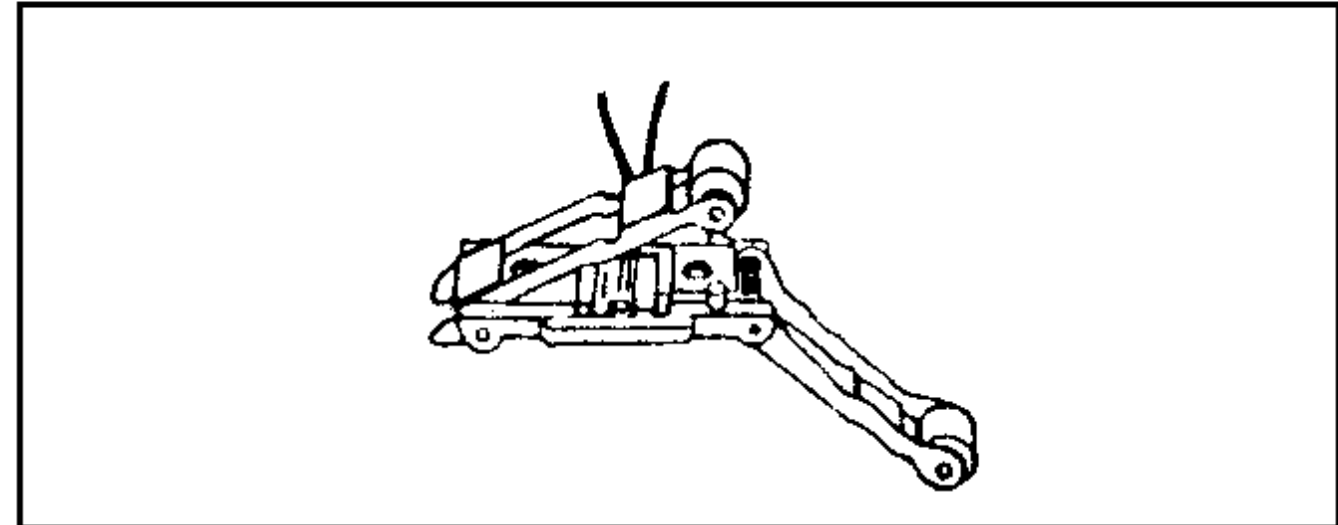
**Reason d:** Contact roller arm exerts too much pressure against the center rail throwing locomotive off.

**Correction:** Relieve tension on contact roller arm spring. Let down the collector assembly and bend collector arm back as illustrated below.
