# Corrosion-induced cracking of model train zinc-aluminium die castings

NLR-TP-2005-205

R.J.H. Wanhill and T. Hattenberg

**National Aerospace Laboratory NLR, Amsterdam, The Netherlands**

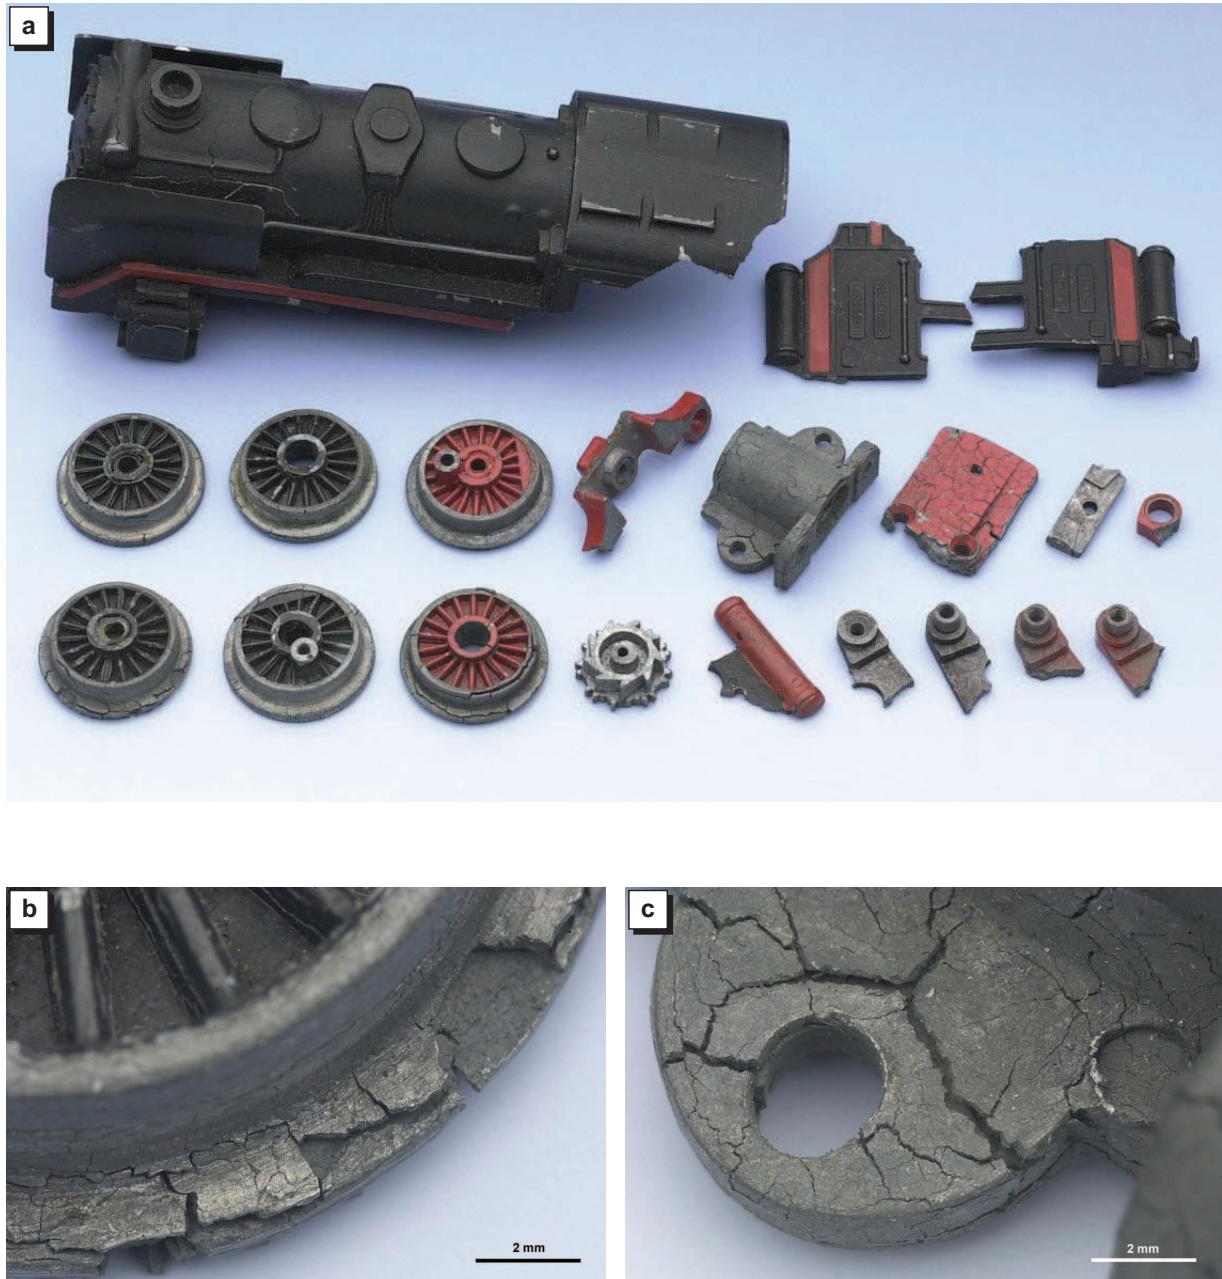
*Fig. 1 Severe corrosion-induced cracking in a zinc-aluminium die cast model locomotive, vintage 1946-1947. The details in figures 1b and 1c show part of a wheel and a block fitting*

Some model train die castings made from zinc-aluminium alloys and produced in the first decade after World War II have shown susceptibility to corrosion-induced cracking. The susceptibility varies, but in severe cases leads to disintegration of the model, see figure 1.

Figure 4 gives examples of the microstructures of the wheel and block shown in figures 1b and 1c. The wheel's microstructure consists of fine  $\beta$  crystals surrounded by fine eutectic, indicating rapid solidification. The block's microstructure is coarser, owing to less rapid solidification, and there is relatively more eutectic, whose lamellar structure is evident. Also, at this magnification it is just possible to observe  $\alpha$  particles within the  $\beta$  crystals: see also figure 8b.

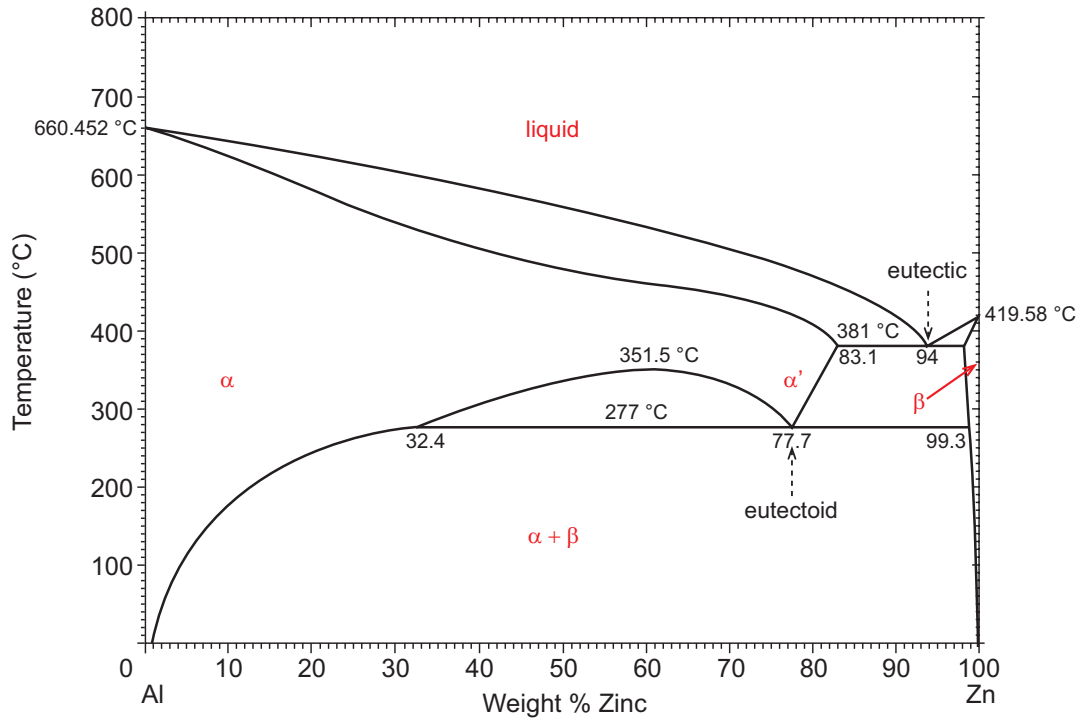
Fig. 2 Zinc-aluminium equilibrium phase diagram: permission ASM International, see Baker et al. (1992), p. 2-56

As table 1 shows, current zinc die castings are basically binary alloys of zinc and aluminium. The starting point for understanding the metallurgy of these alloys is the zinc-aluminium equilibrium phase diagram, figure 2. The main features of this diagram are:

- Liquid alloy undergoes a eutectic transformation at the composition 94 wt.% Zn-6 wt. % Al and at 381°C. The transformation products are the  $\alpha'$  phase (83.1 wt. % Zn) and  $\beta$  phase (98.8 wt. % Zn).
- Below 277°C the  $\alpha'$  phase is unstable and undergoes a eutectoid transformation. The transformation products are  $\alpha$  phase (32.4 wt. % Zn) and  $\beta$  phase (99.3 wt. % Zn).
- The solid solubility of aluminium in  $\beta$  decreases from 1 wt. % at the eutectic temperature to almost zero at room temperature. The solid solubility of zinc in  $\alpha'$  decreases from 83.1 wt. % at the eutectic temperature to 77.7 wt. % just before the eutectoid transformation. The solid solubility of zinc in  $\alpha$  decreases from 32.4 wt. % at the eutectoid temperature to about 1 wt. % at room temperature.

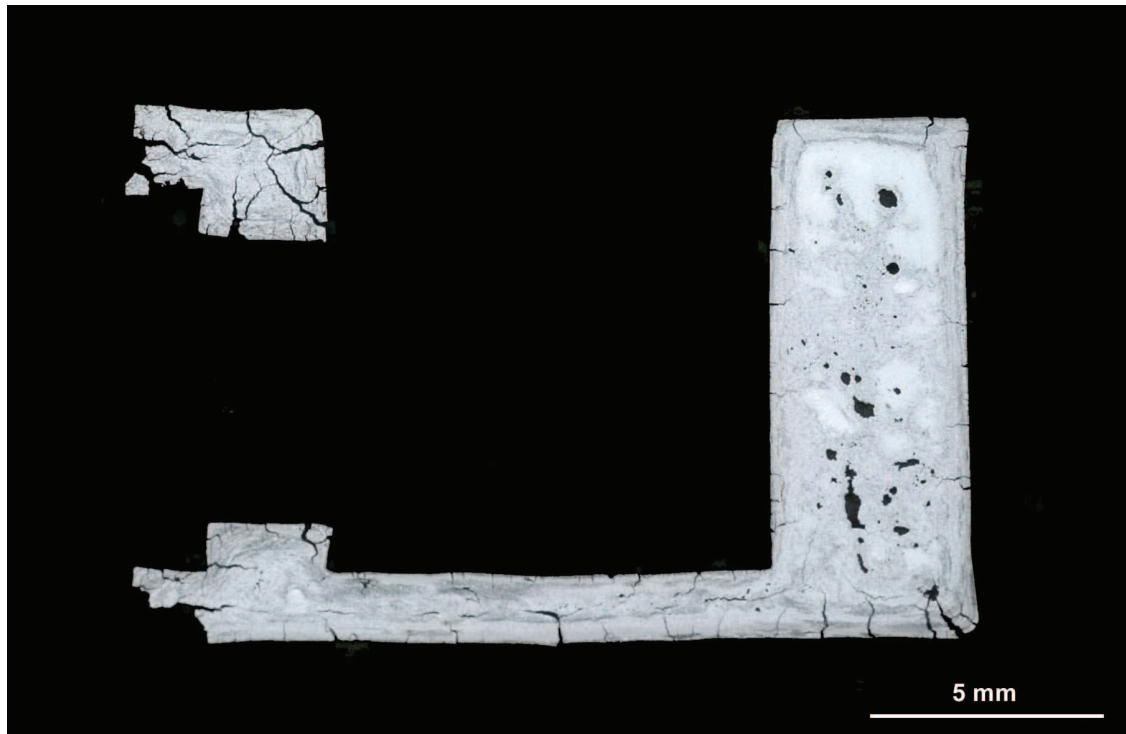
*Fig. 5 Metallographic overviews of the cracking in the wheel (top) and block (bottom). Note the porosity also*

Figure 5 gives metallographic overviews of the cracking in the wheel and block. The cracks began from the external surfaces. Note the porosity owing to gas entrapment during casting, especially throughout the wheel. This indicates non-optimum casting practice, although the pores would not have affected using the components.
