# SERVICE MANUAL

OTTP 95

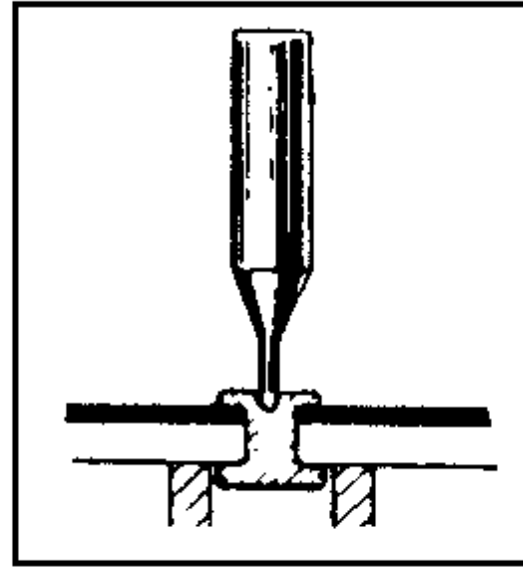
Do not attempt to drill out the rivets since the drill will only cause the rivet to spin. To push out rivets use Punch ST350-20 and Anvil ST350-22 which are included in the ST-350 Riveting Set.
