SERVICE MANUAL

OTEP 95

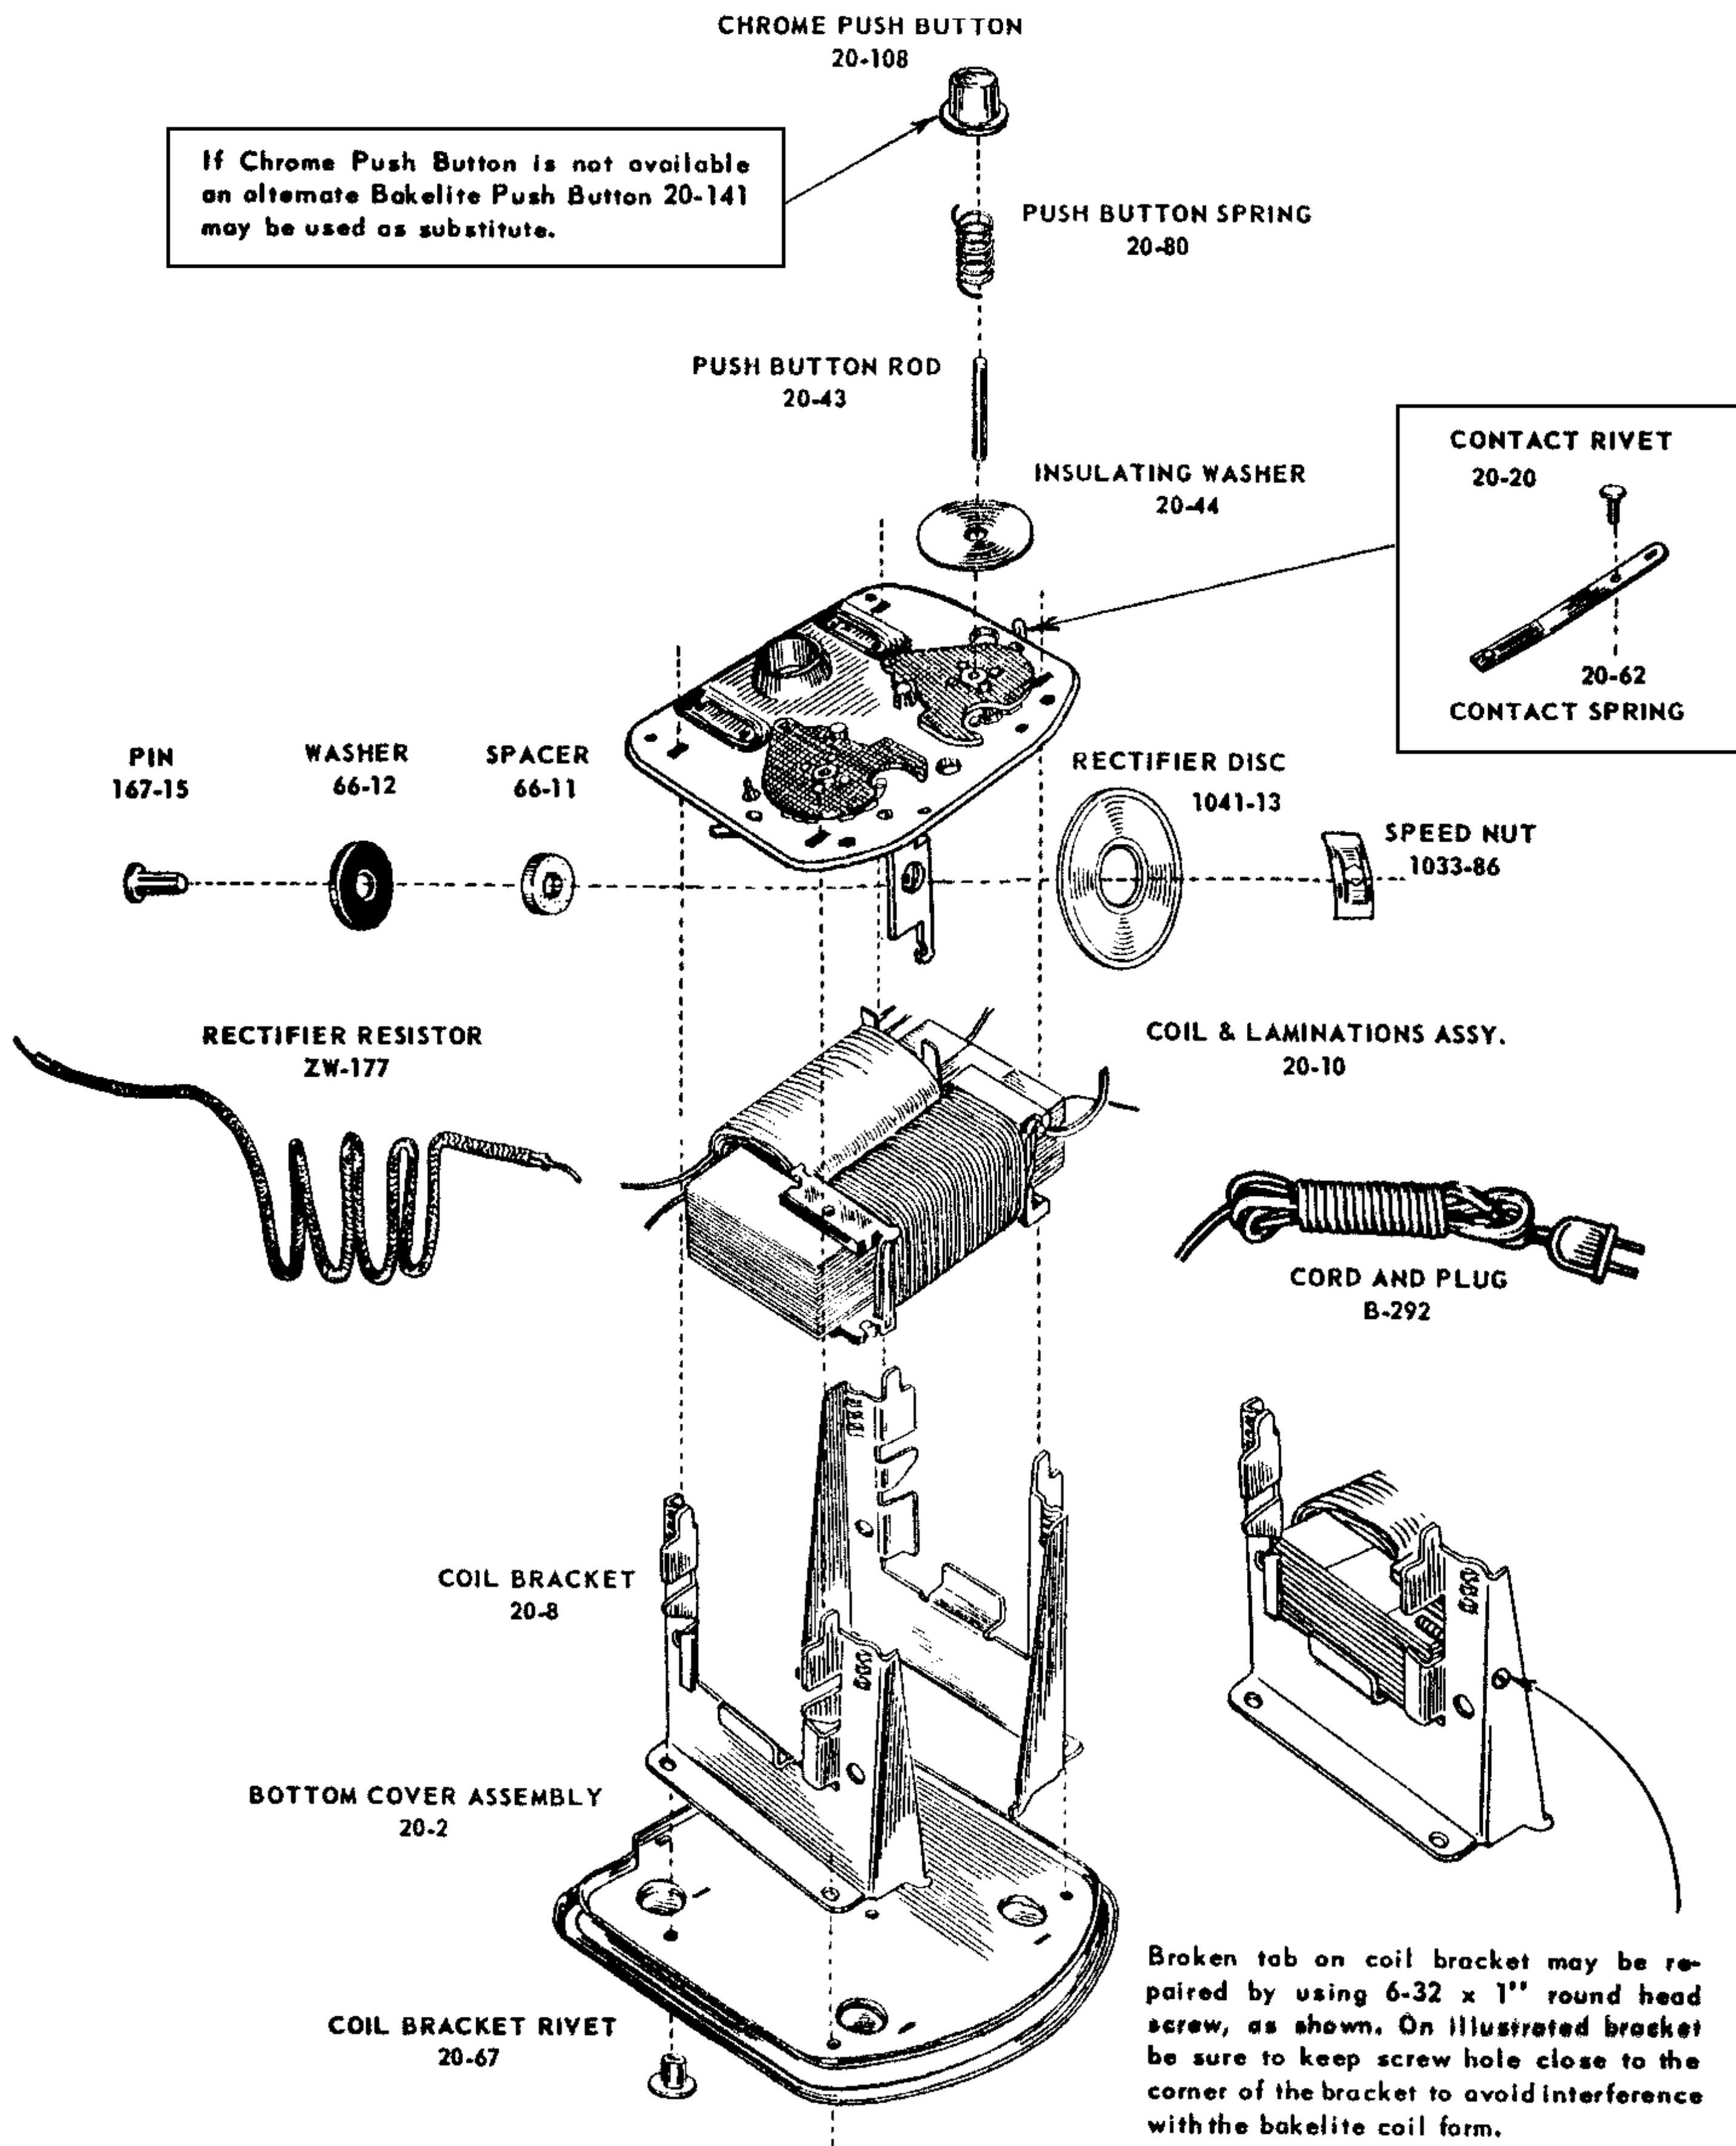
Broken tab on coil bracket may be repaired by using 6-32 x 1" round head screw, as shown. On illustrated bracket be sure to keep screw hole close to the corner of the bracket to avoid interference with the bakelite coil form.
